Manhole Inspection Summary

Manhole # S39II_022MH

Insp Date: **10/19/07 11:18 AM**

Location Address: **1448 ASQUITH ST**

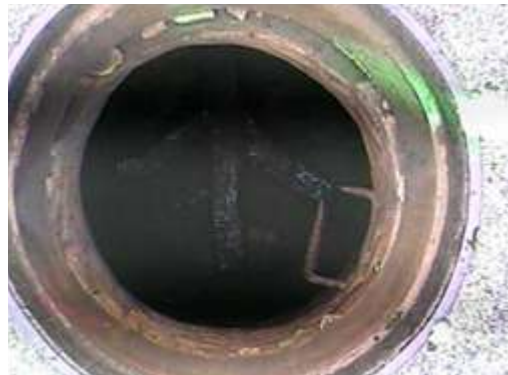
Defect 2

Offset: **1** (in.)

FRAME OFFSET

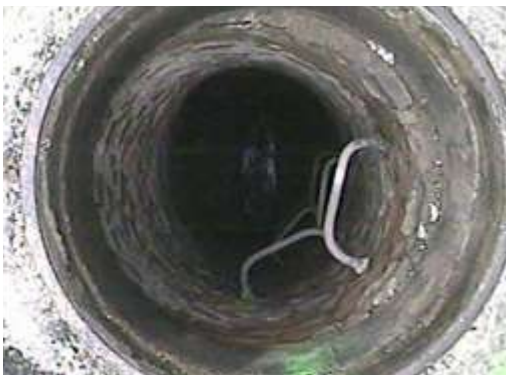
Defect 3

Count: **5** Missing: **2** ☒ **Corroded**

STEPS CORRODED

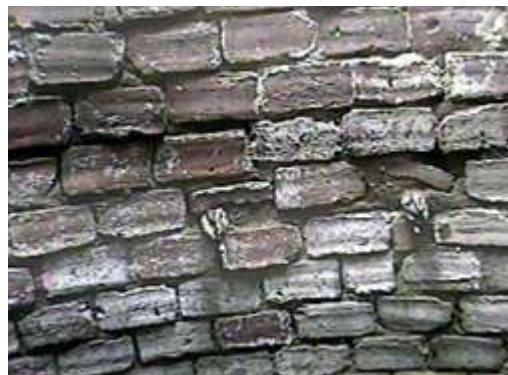
Defect 1

Condition: ☐ Sound ☐ Cracked ☐ Root Intrusion ☒ **Loose Brick** ☐ Deteriorated

CHIMNEY LOOSE BRICKS

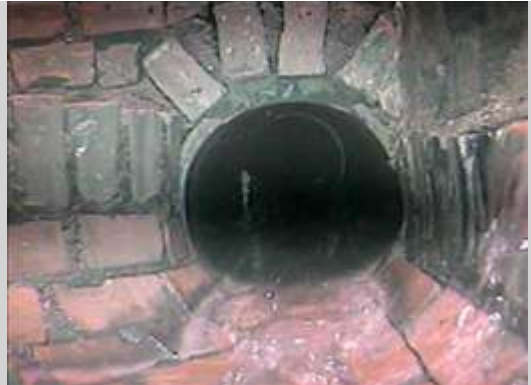
12 O'Clock Outflow

8 in. Circular Gravity Sewer
Pipe Out @ 12 O'Clock

Pipe Height: (in.) Direct
Pipe Material: **Clay** ☐ Pipe Lined
Invert Depth: **9.04** (ft.) Flow Characteristics: **Fast**
Deposits: ☒ None ☐ Mud ☐ Sludge ☐ Debris ☐ Grease
Silt Depth: (in.) Deposits Extent:
Infiltration: **None** Pipe Seal Cond: **Sound**

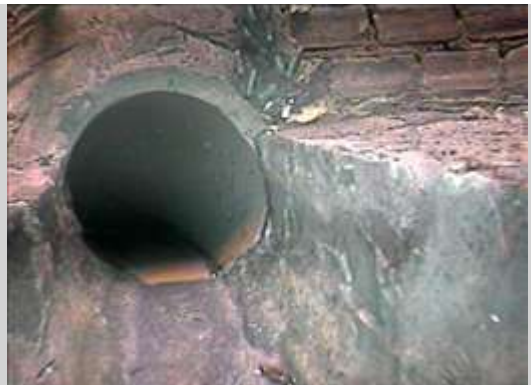
3 O'Clock Inflow

8 in. Circular Gravity Sewer
Pipe In @ 3 O'Clock

Pipe Height: (in.) Direct
Pipe Material: **Clay** ☐ Pipe Lined
Invert Depth: **8.22** (ft.) Flow Characteristics: **Fast**
Deposits: ☒ None ☐ Mud ☐ Sludge ☐ Debris ☐ Grease
Silt Depth: (in.) Deposits Extent:
Infiltration: **None** Pipe Seal Cond: **Sound**

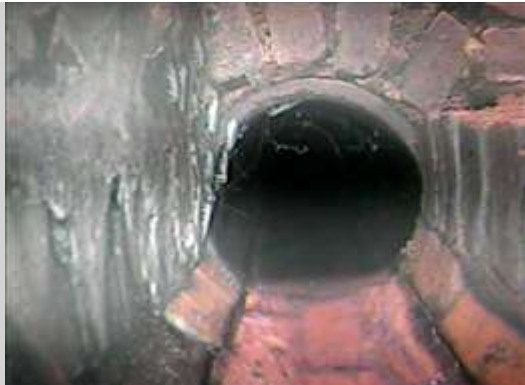
6 O'Clock Inflow

8 in. Circular Gravity Sewer

Pipe In @ 6 O'Clock

Invert Depth: **8.85** (ft.) Flow Characteristics: **Fast**

Infiltration: **None** Pipe Seal Cond: **Sound**

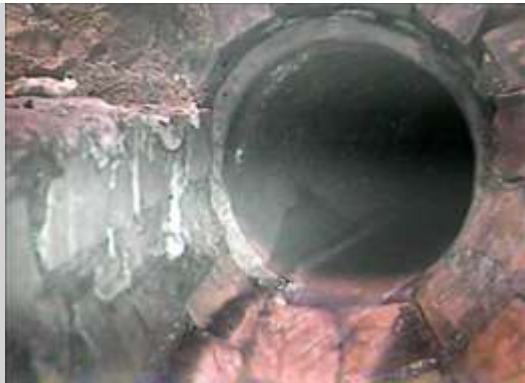
9 O'Clock Inflow

8 in. Circular Gravity Sewer

Pipe In @ 9 O'Clock

Invert Depth: **8.80** (ft.) Flow Characteristics: **Fast**

Infiltration: **None** Pipe Seal Cond: **Sound**
